RESTORATION WORKS TO THE SCULPTURAL ENSEMBLE BY JOSEPH WILTON, LADY ANNE DAWSON TEMPLE, DARTREY ESTATE, CO. MONAGHAN

© Eoghan Daltun, sculpture conservator, 2015.

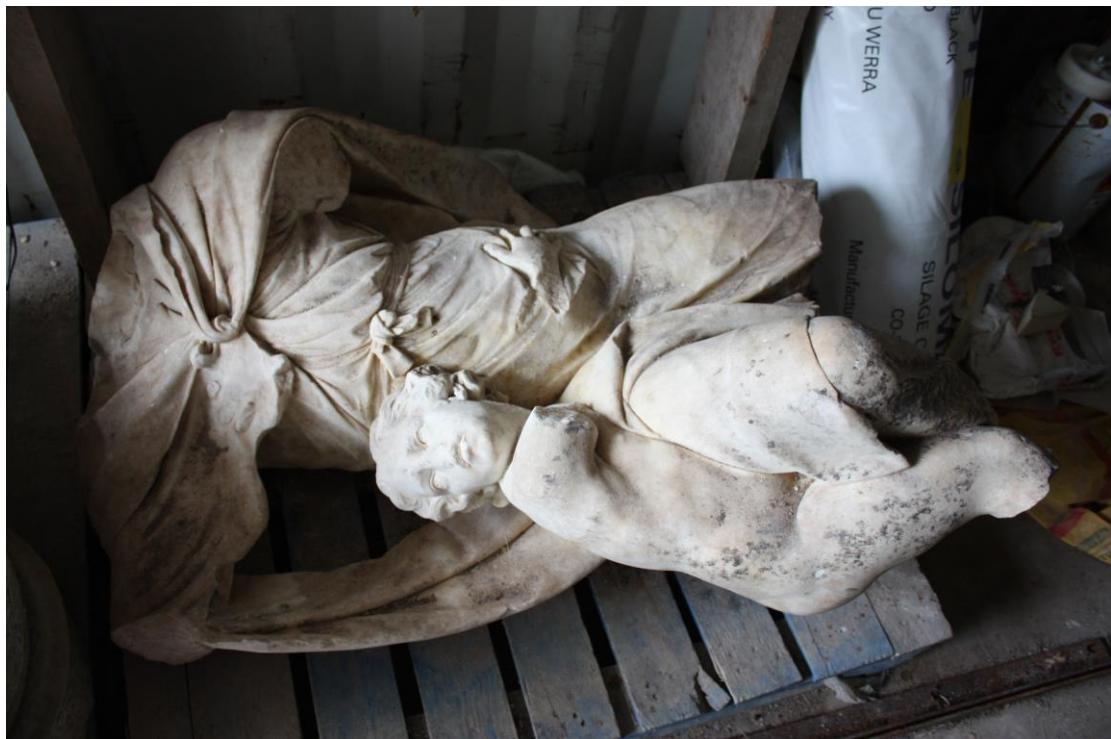
Fig. 2. Torso of Lord Dartrey and child, prior to works.

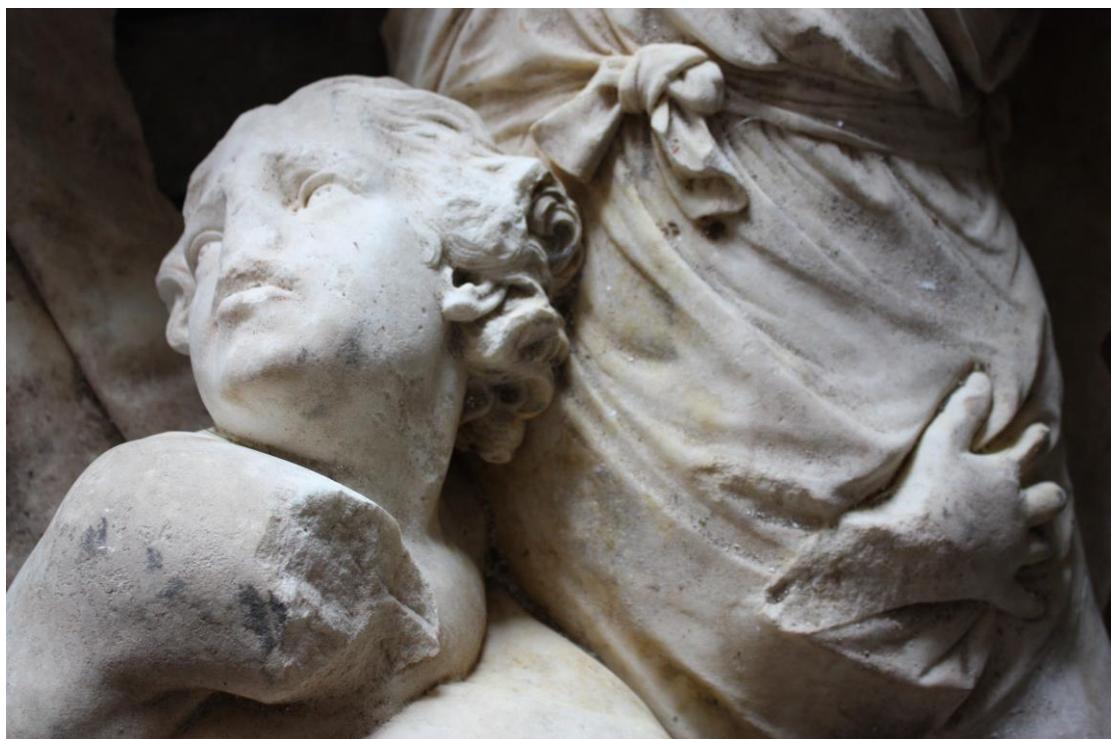
Fig. 3. Detail of child, prior to works.

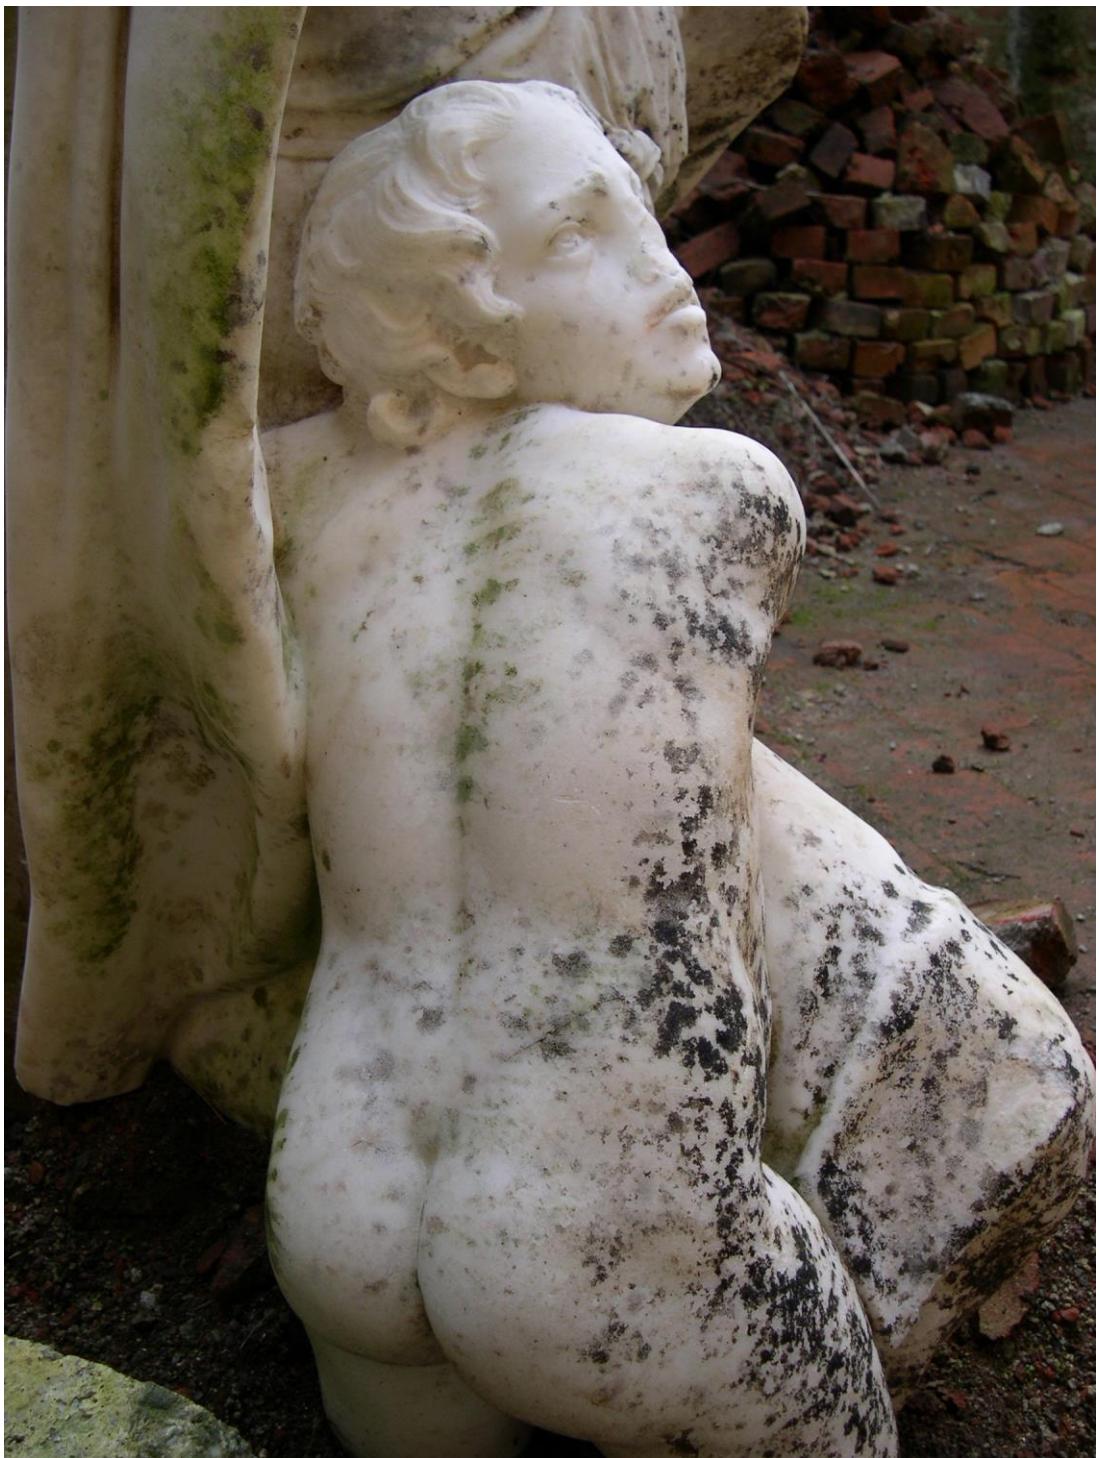
Fig. 4. Detail of child after being salvaged from the rubble of the Temple, amongst which it had lain exposed to the elements for several decades.

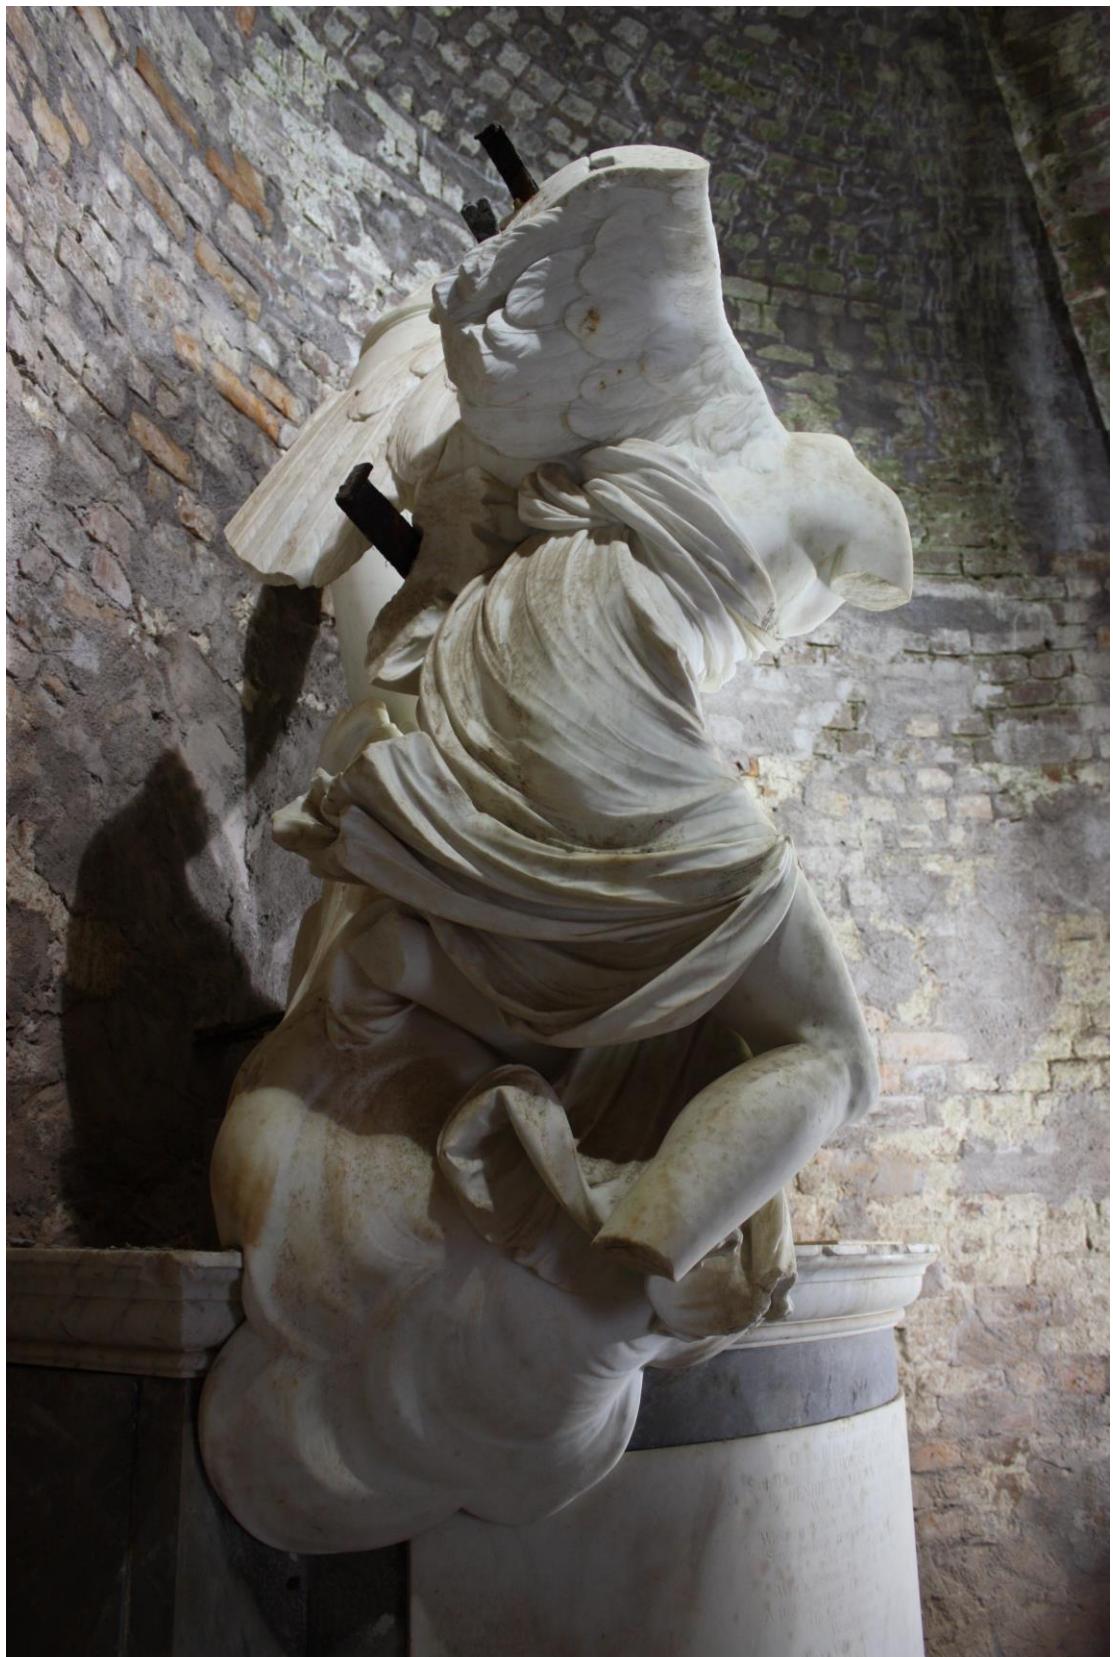
Fig. 5. The angel, prior to works.

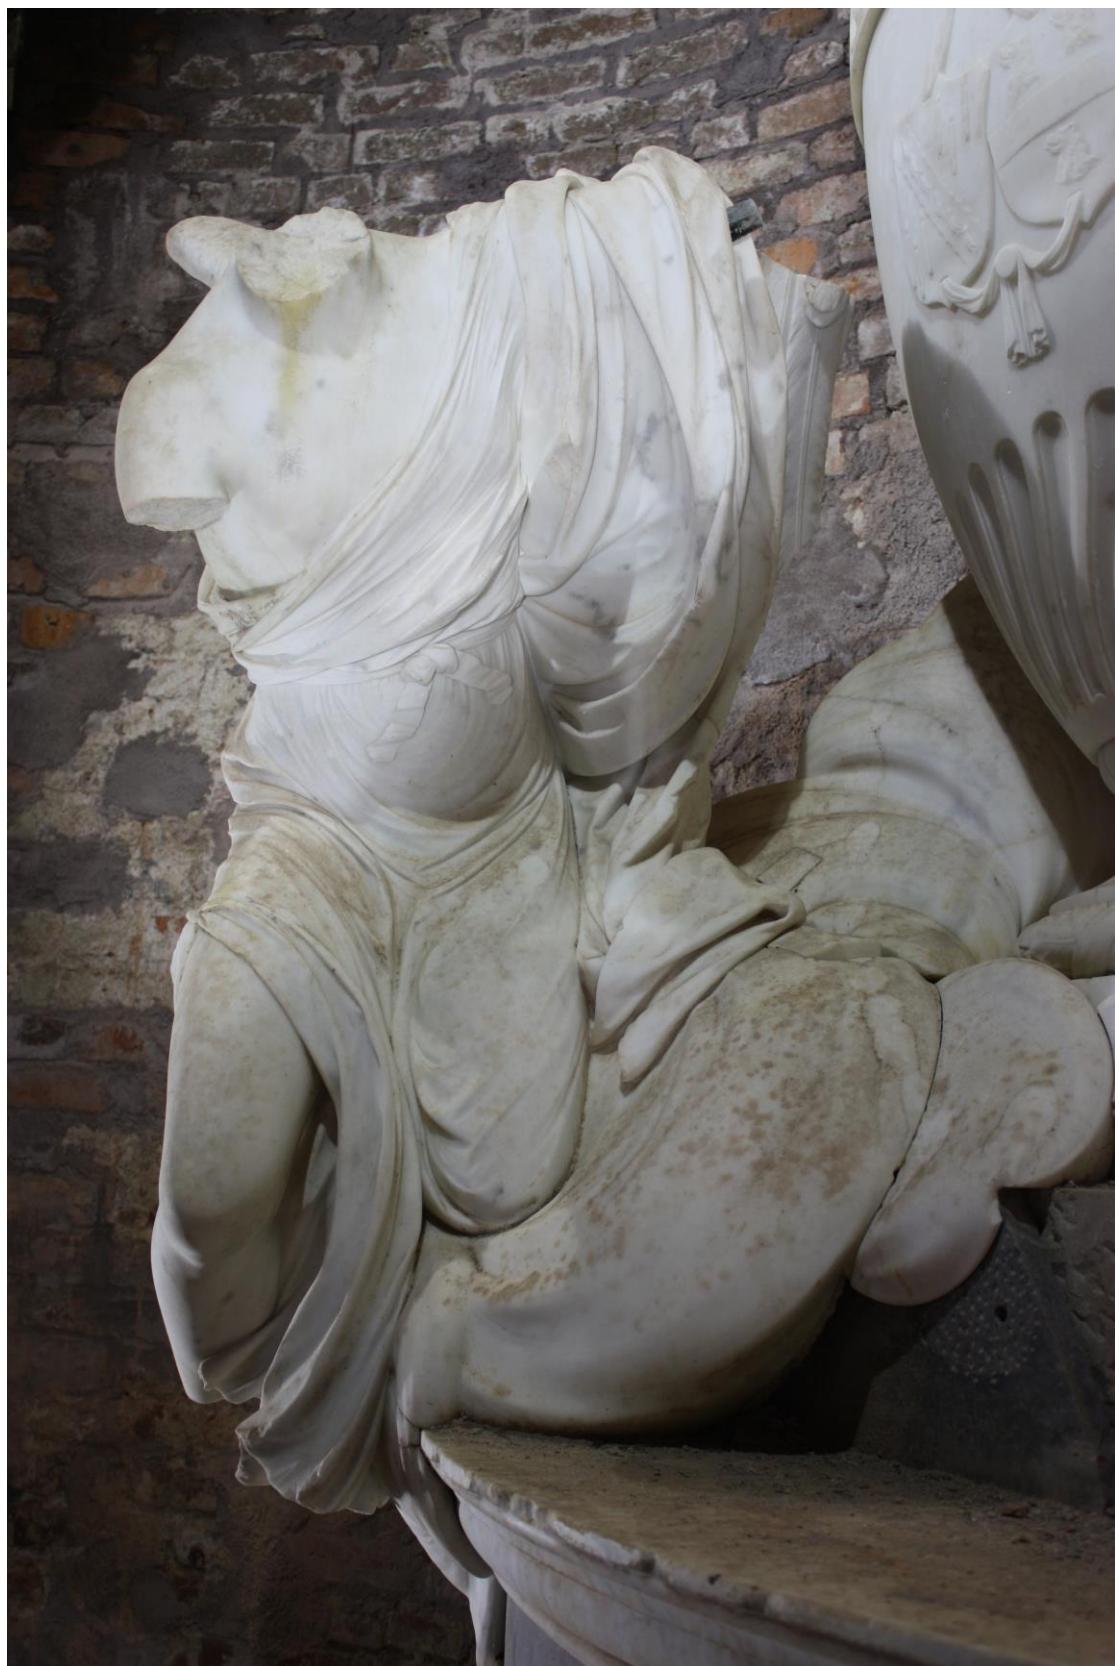
Fig. 6. The angel, prior to works.
