CONSERVATION AND RESTORATION WORKS TO 8NO. EARLY MEDIEVAL CARVINGS, LISMORE CATHEDRAL, CO. WATERFORD

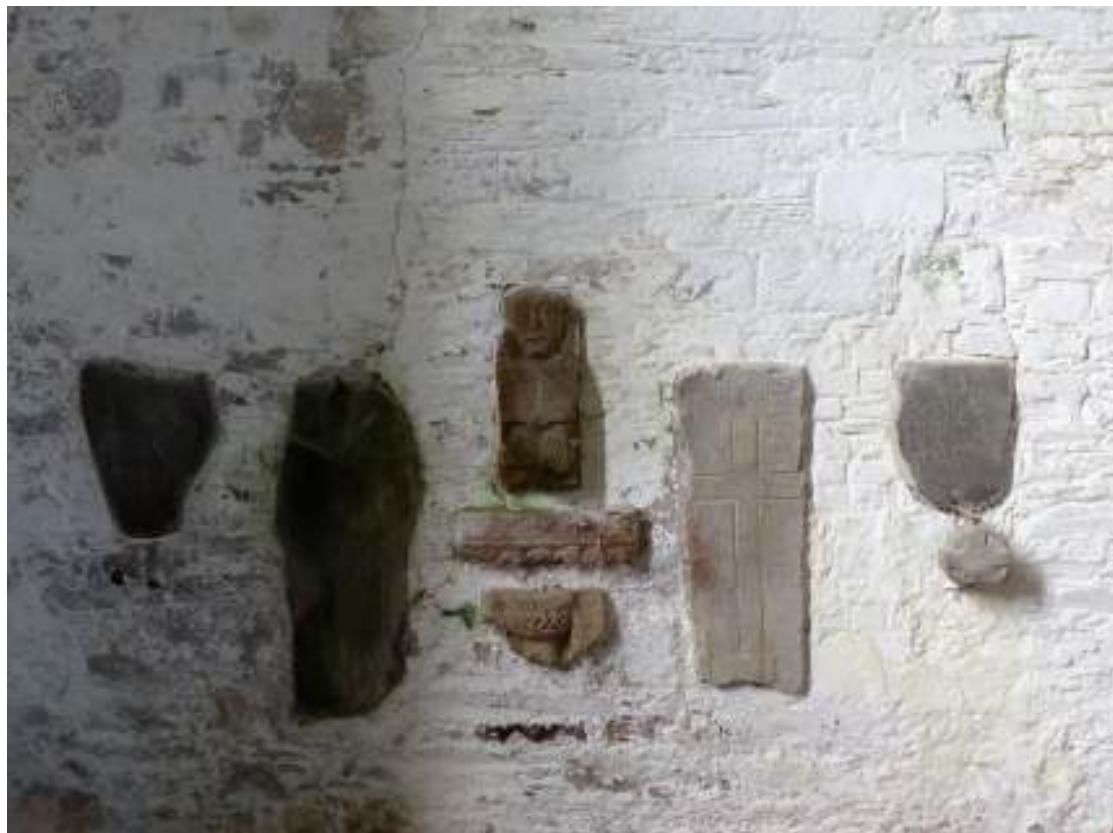
Fig. 1; Prior to works: the carvings had been set into the interior masonry wall with Portland cement, probably in the 1950s or '60s.

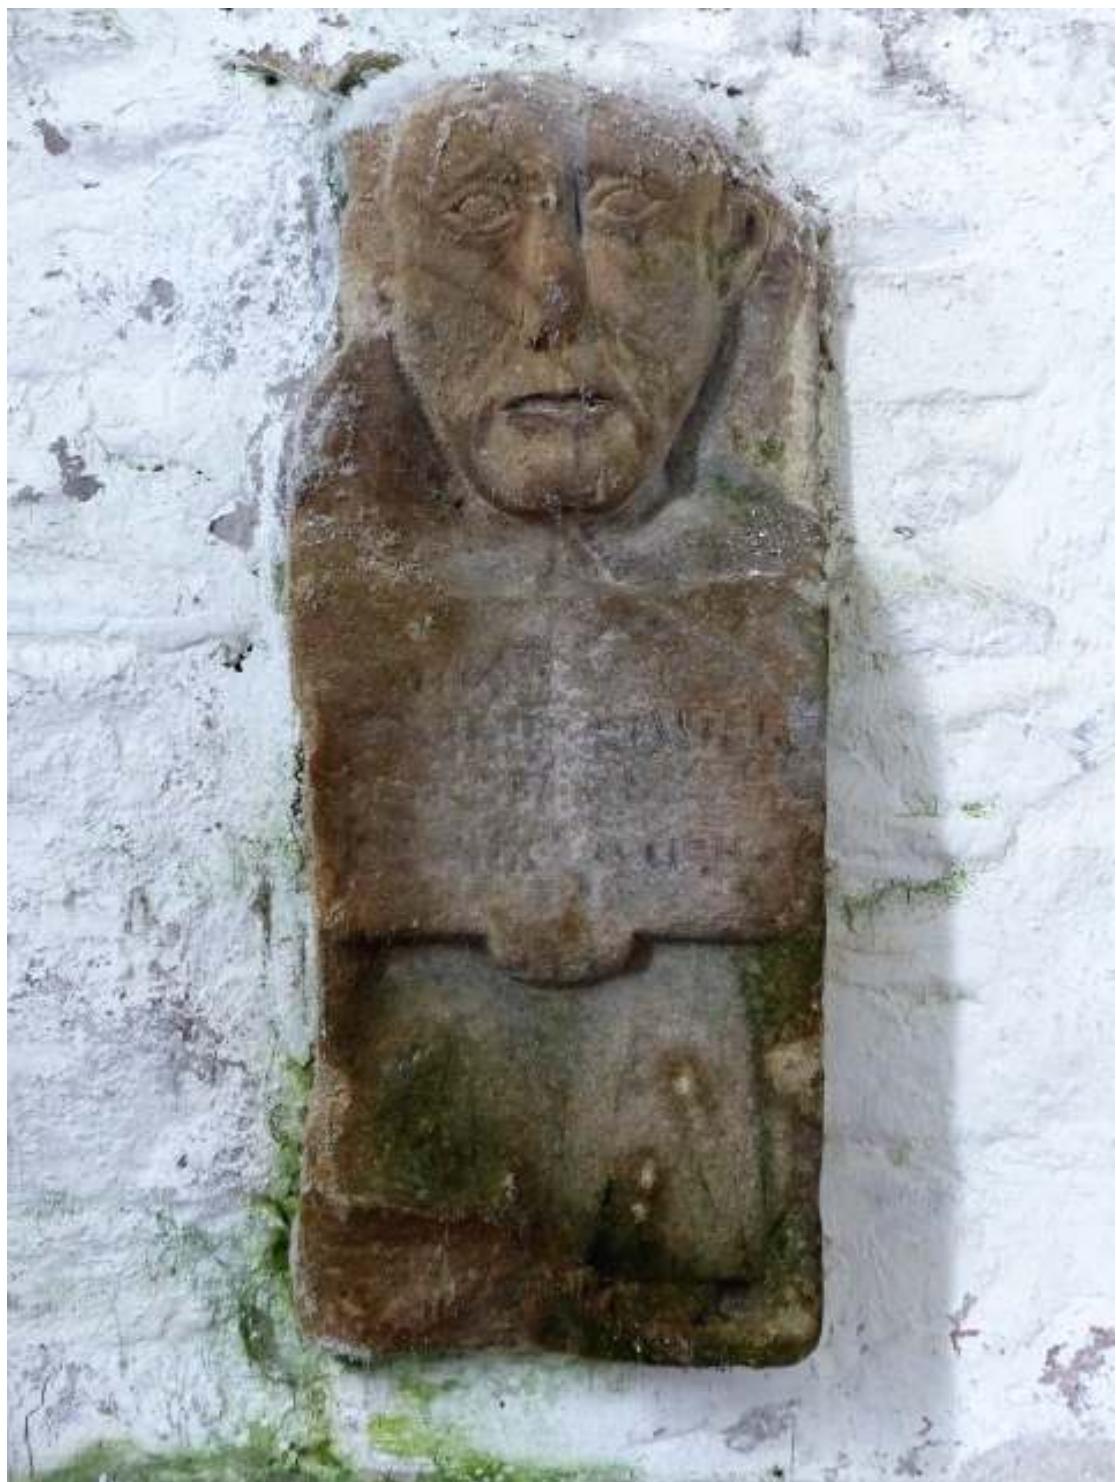
Fig. 2; One of the pieces prior to works, showing harmful biological growth and efflorescence on the stone surface due to serious dampness in the wall.

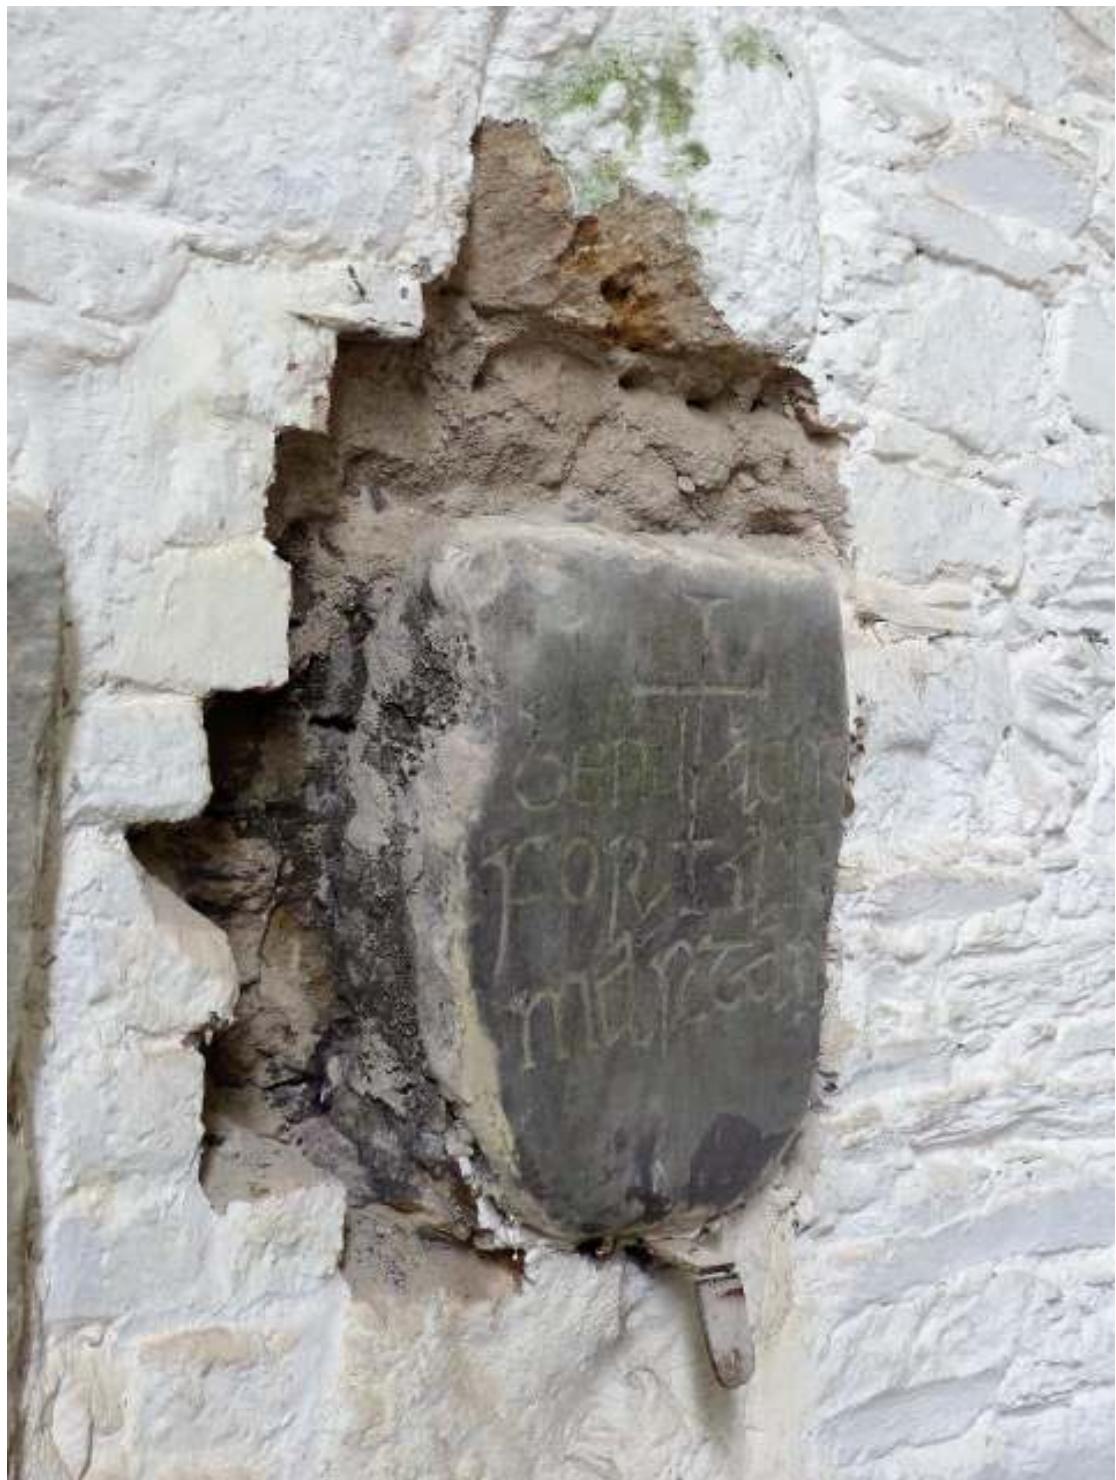
Fig. 3; Careful removal of surrounding masonry in order to safely extract the carvings.

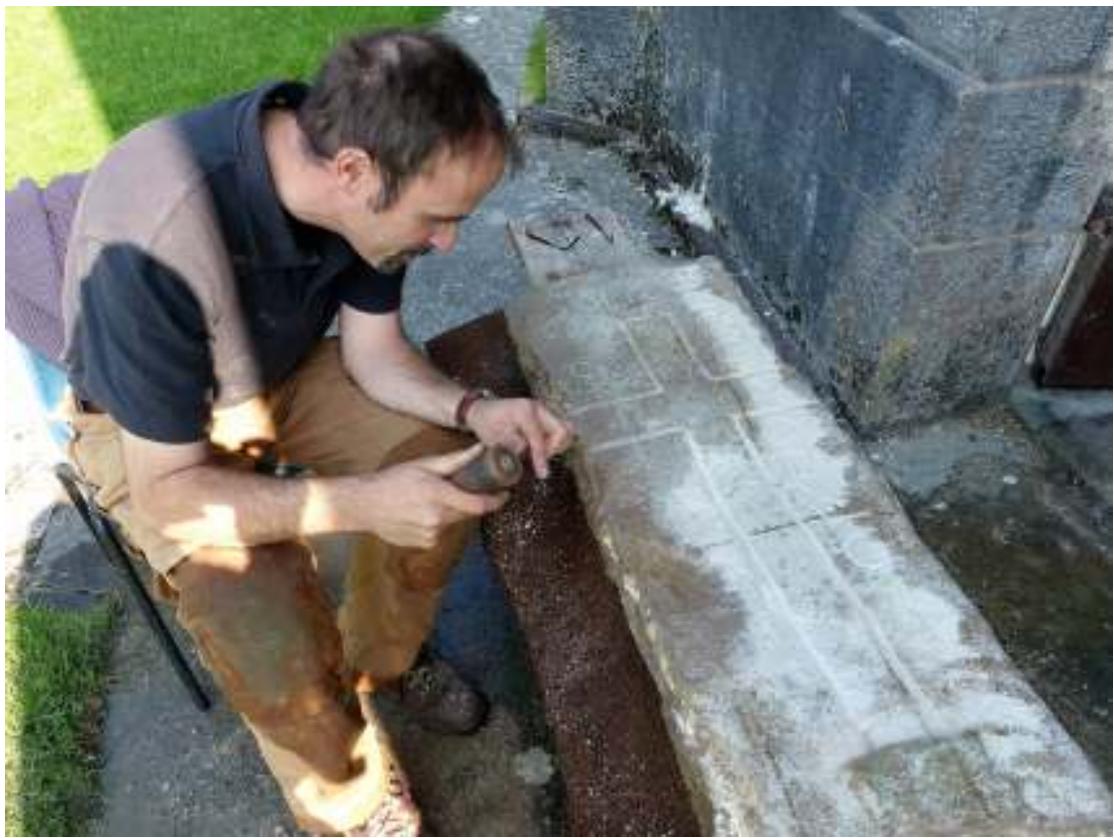
Fig. 4; After extraction from the wall: removal by hand of attached cement mortar from sides and rear of carving.

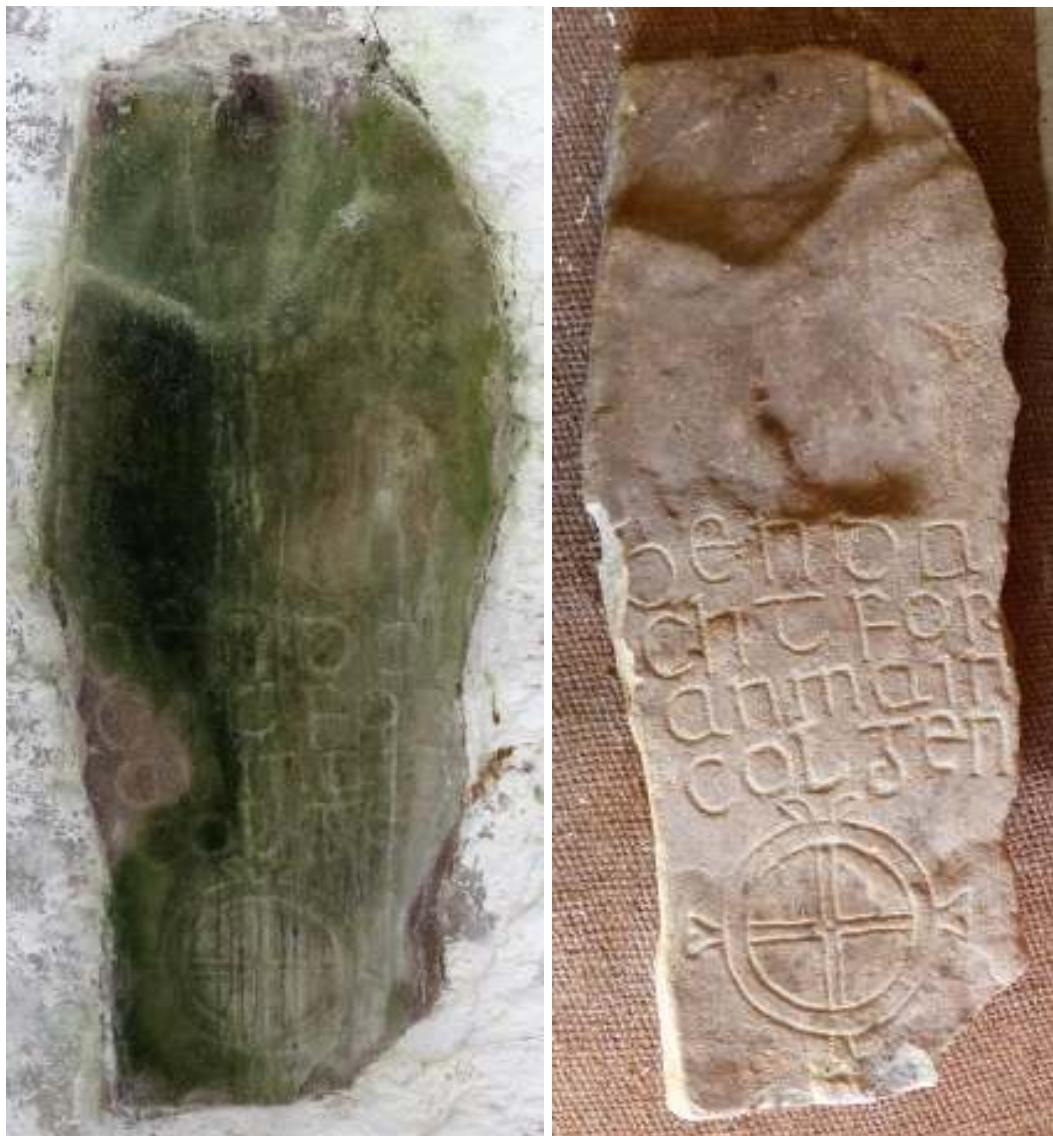
Figs. 5 & 6; One of the longer cross slabs before and after works.
